Woodcote House, Leek Wootton, Warwick, CV35 7QA

Condition Survey Report for
Warwickshire Police and Crime Commissioner
December 2023
Our Ref: AR/23-02515

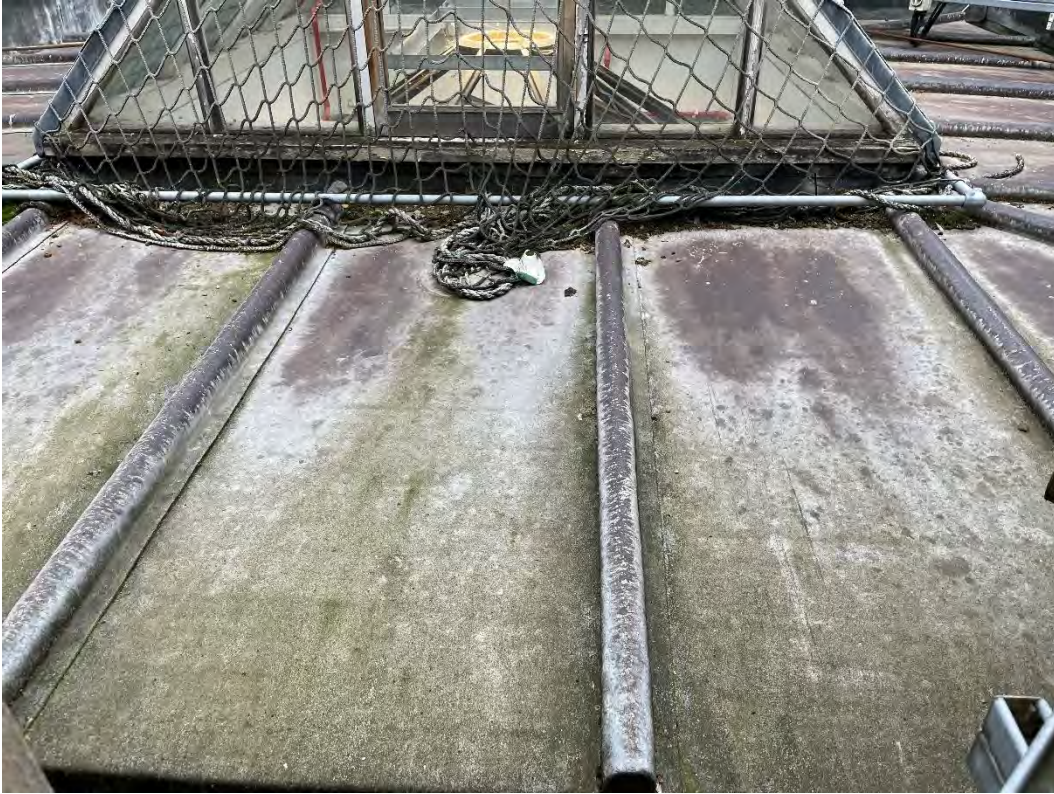
1009) Typical condition of leadwork

- 3.4.21 We have not been able to undertake a detailed close inspection, however, the lead covering, whilst soiled, appeared to be in good condition with no obvious signs of splits. The entire covering should be cleaned and cleared, at which point a detailed inspection should be undertaken.

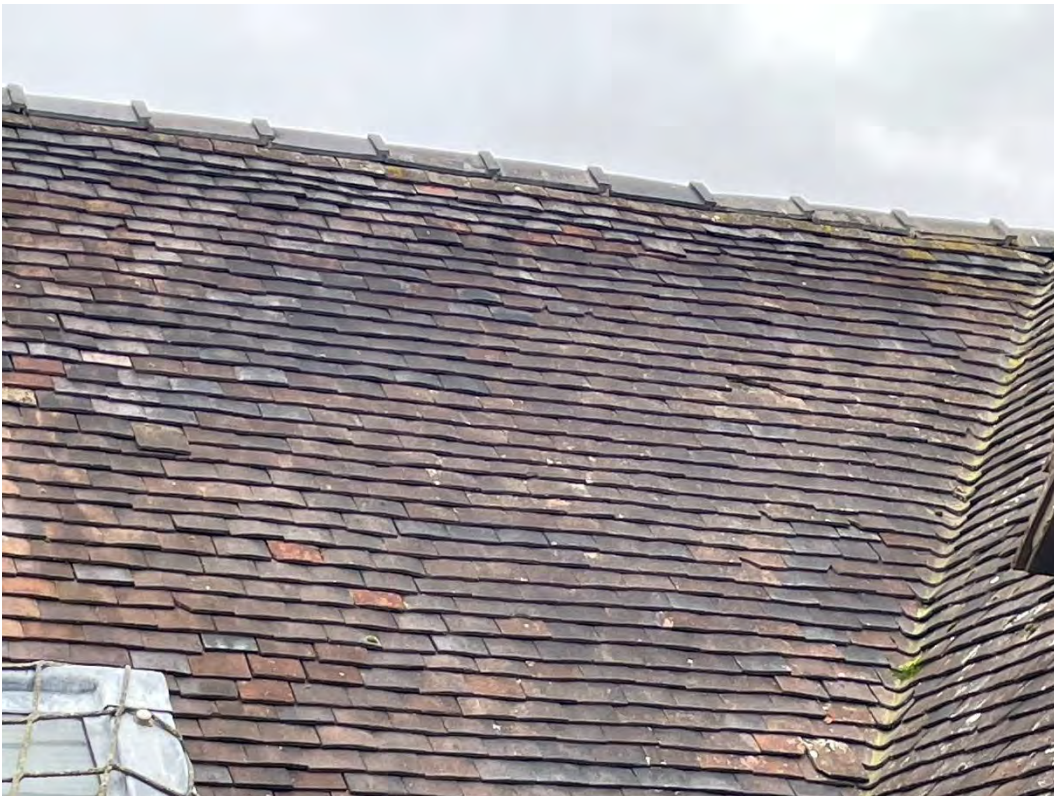
- Accumulation of moss and lichen growth throughout.
- Accumulation of vegetation growth and detritus within the gutters and valleys.
- Deteriorated mortar joints to ridge tiles.
- Deteriorated, fragile or otherwise defective plain tiles and ridge tiles in need of replacement.
- Slipped plain tiles, possibly due to nail fatigue.

1010) Typical condition of roof pitch – slipped and damaged tiles

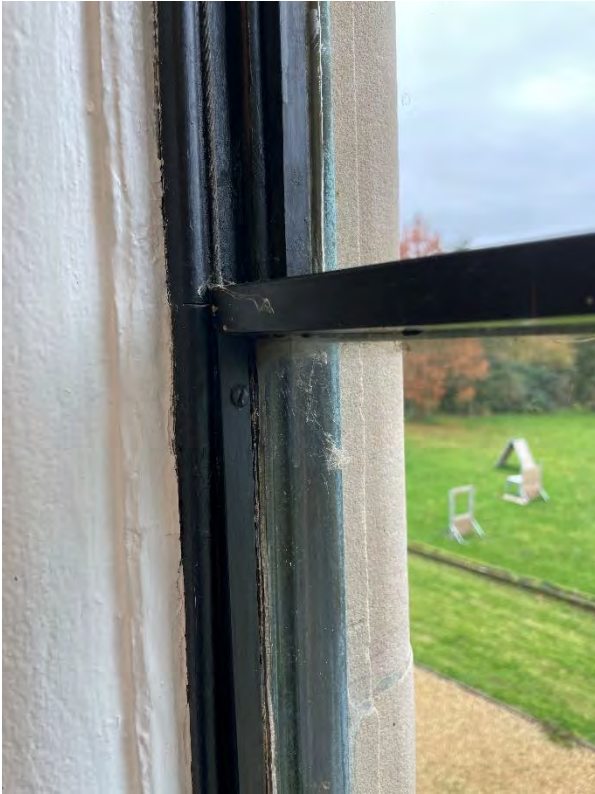
1011) Internal view of typical sash window

- 3.8.2 The sash windows and mechanisms were built into external walls and stone mullions, and most windows had metal string chords which were intact. It is prudent to annually clean and wax the sliding sash windows to ensure smooth operation. A random sample of windows were tested during our inspection, and some were found to be sticking.

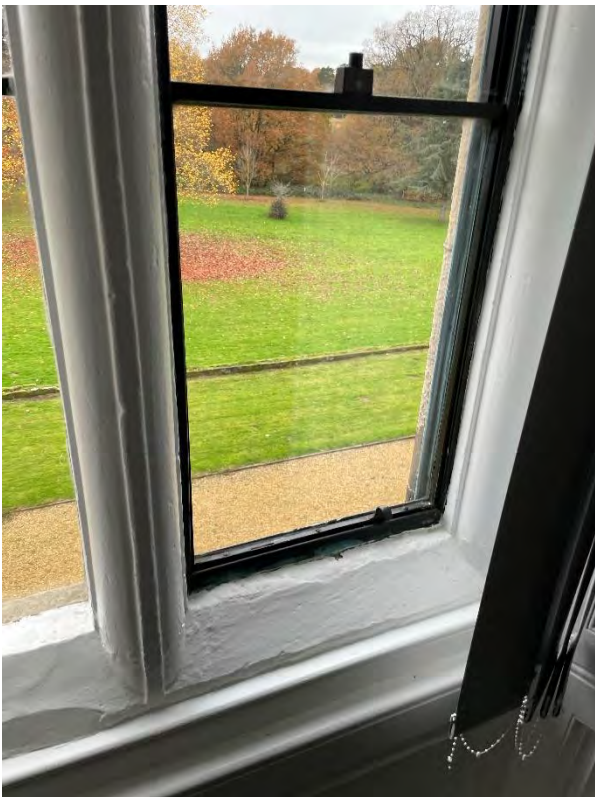
1012) Internal view of typical sash window

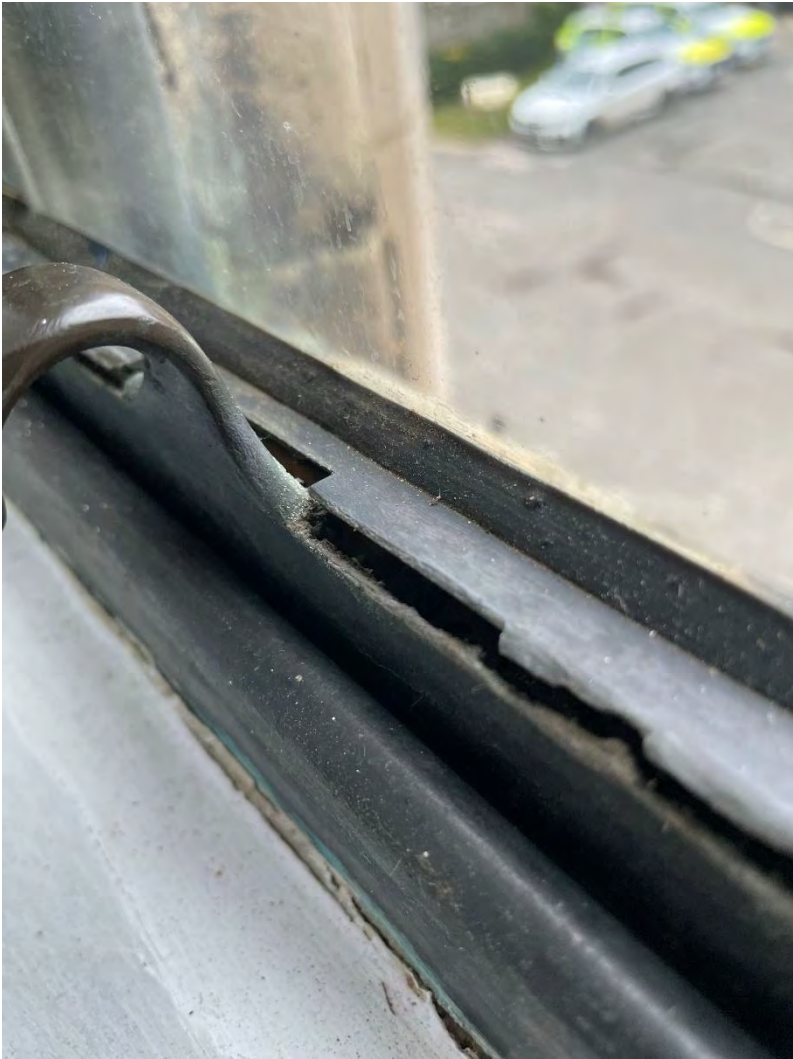
- 3.8.3 A small number of the sash windows exhibited splitting along the bottom rail revealing the hollow interior of the sash framing. This would require a bespoke repair solution from a specialist craftsman, given that this is an opening part of a window. However, we have not included for the repair within our budget costs due to the specialist nature.

1013) Typical split to metal of sash windows

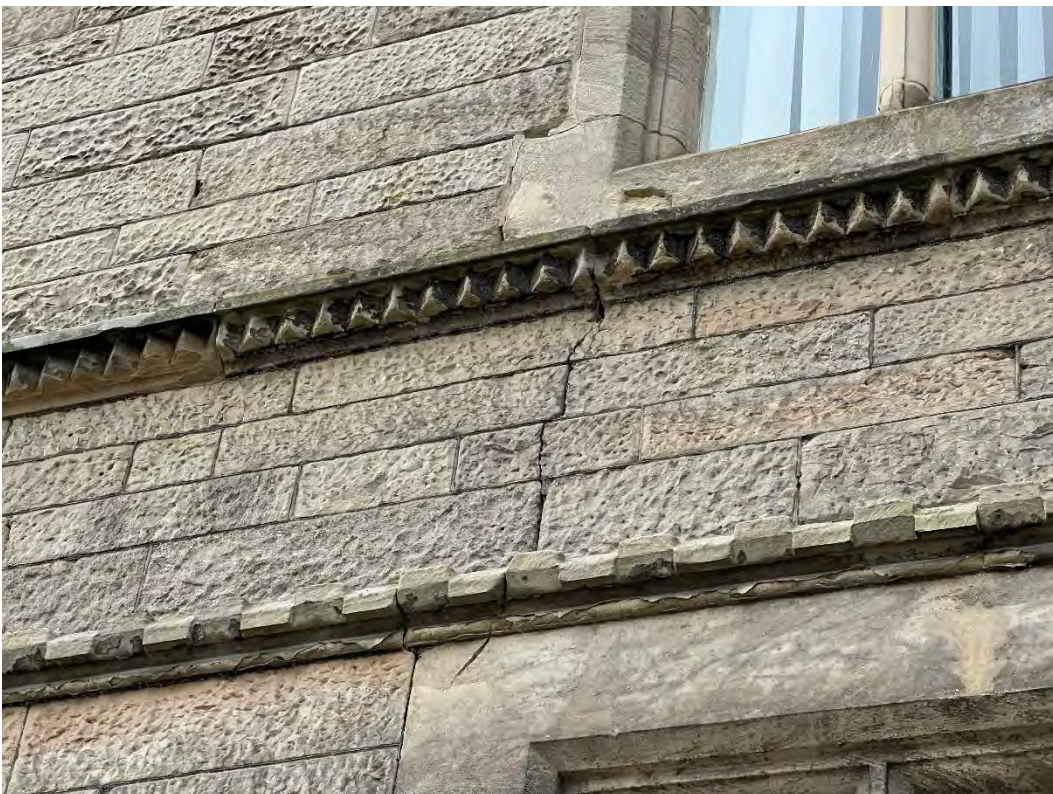
3.3.1 Rapleys have not undertaken a review of the structure within the property however, we did identify cracking to the masonry to both the South (Left) and East (Front) elevations. These cracks appear to run between windows and may be the result of failing concealed lintels. Stitching repairs are anticipated during the stone repair works however we recommend a Structural Engineer is appointed to undertake a review of the cracking and possible repairs required.

1016) Cracking to Front (East) elevation

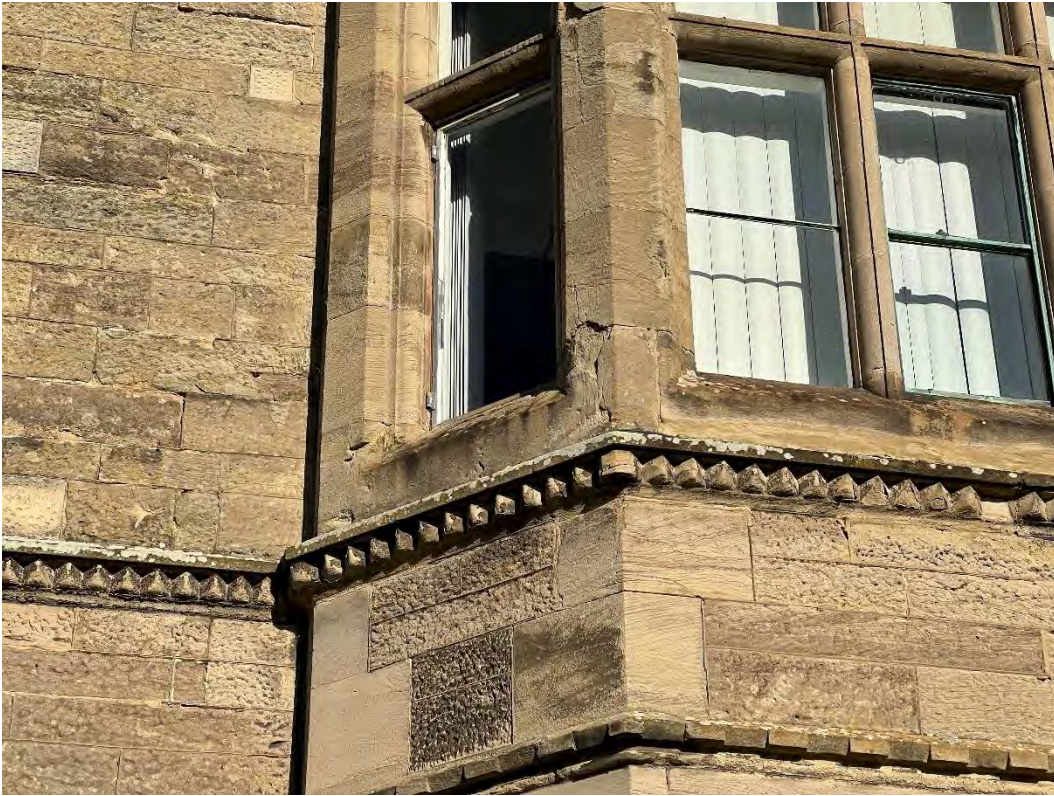
1017) Typical example where replacement stone is required

5.	<p>Full Replacement Stone - Ensure the minimum amount of original stone is removed and exercise caution not to damage adjacent stone. For small areas cut out the defective stone with a sharp chisel and stone saw for larger stones, use non-percussive drills, pneumatic chisel or angle grinders.</p> <p>Remove any friable material or debris and clear the cavity. If the new stone is not to be installed immediately, ensure sufficient temporary propping is and packing is provided.</p> <p>New stone to be cut to size from the chosen block of matching stone. Contractor to ensure that the new stone is laid in the correct bed and always finished by hand to match the appearance of the rest of the wall.</p> <p>Ensure the cavity is wetted to prevent excessive suction. Pack the base and side joints with a suitably sized pointing key. Dry-pack the top bed with a partially dried out, crumbly version of the mortar to prevent shrinkage. Mortar the back of the replacement stone and place into position. Check joint width and ensure that the stone face finishes</p>	<ul style="list-style-type: none"> • Delamination (above 75mm depth) • Contour scaling (above 75mm depth) • Erosion (above 75mm depth) • Spalling (above 75mm depth) • Fractured stonework • Defective stonework of any sort in high risk locations

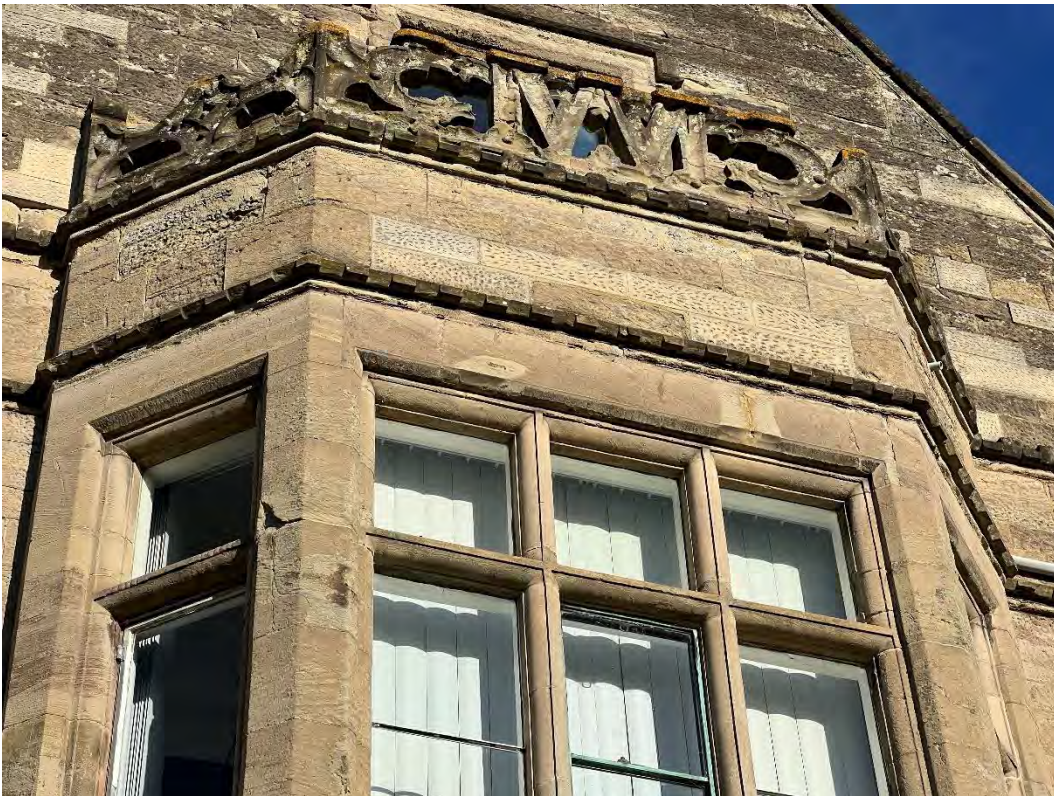
1018) Typical example where partial replacement stone is required

6.	<p>Partial Replacement Stone - Mark up smallest amount of stone that can be removed to retain as much of the stone as possible. Remove defective section of stone with a sharp chisel and stone saw, ensuring not to damage the adjacent stones. Drill the edges of the host stone with a non-percussive drill using a depth gauge.</p> <p>Square off the edges to full depth and finish the cavity to ensure clear from debris.</p> <p>Offer up the replacement stone to ensure it fits into the void.</p> <p>Paint lime putty onto the bottom bed to ensure the thinnest joint around the indent. Ease the indent / replacement stone into place and inject joints with lime grout to finish.</p>	<p>All off the below but where the defect is less than 25% of the affected the stone:</p> <ul style="list-style-type: none"> • Delamination (above 75mm depth) • Contour scaling (above 75mm depth) • Erosion (above 75mm depth) • Spalling (above 75mm depth) • Fractured stonework • Defective stonework of any sort in high risk location

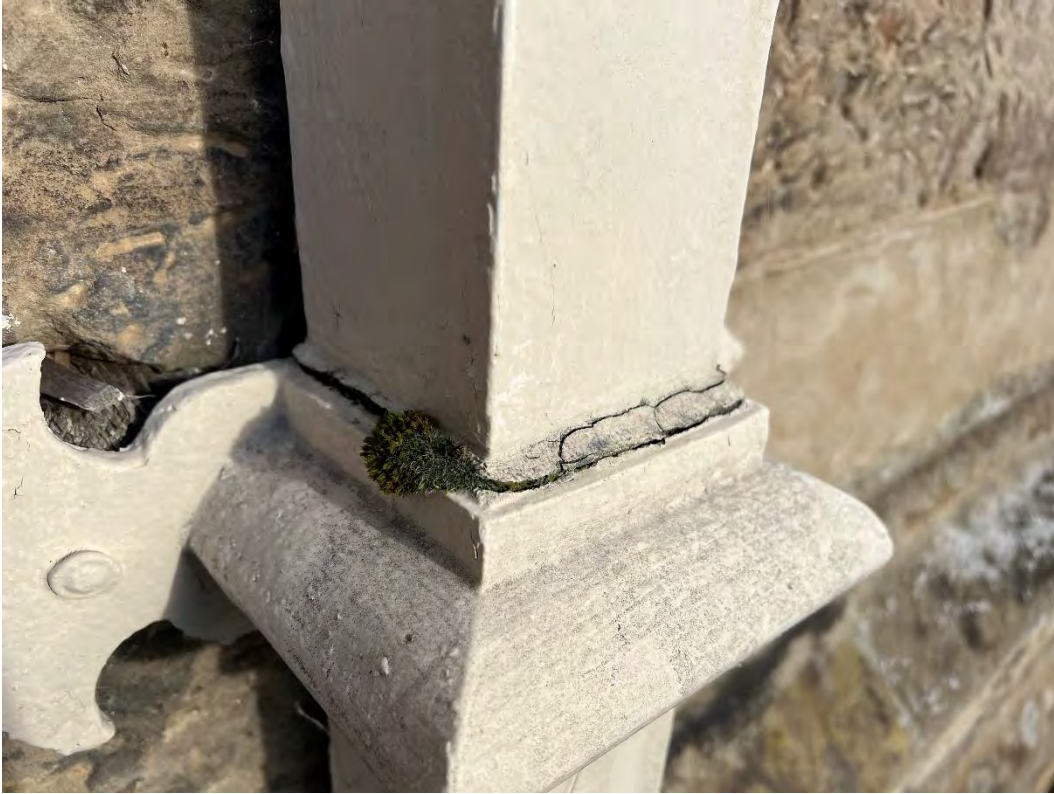
1019) Typical condition of downpipe joints

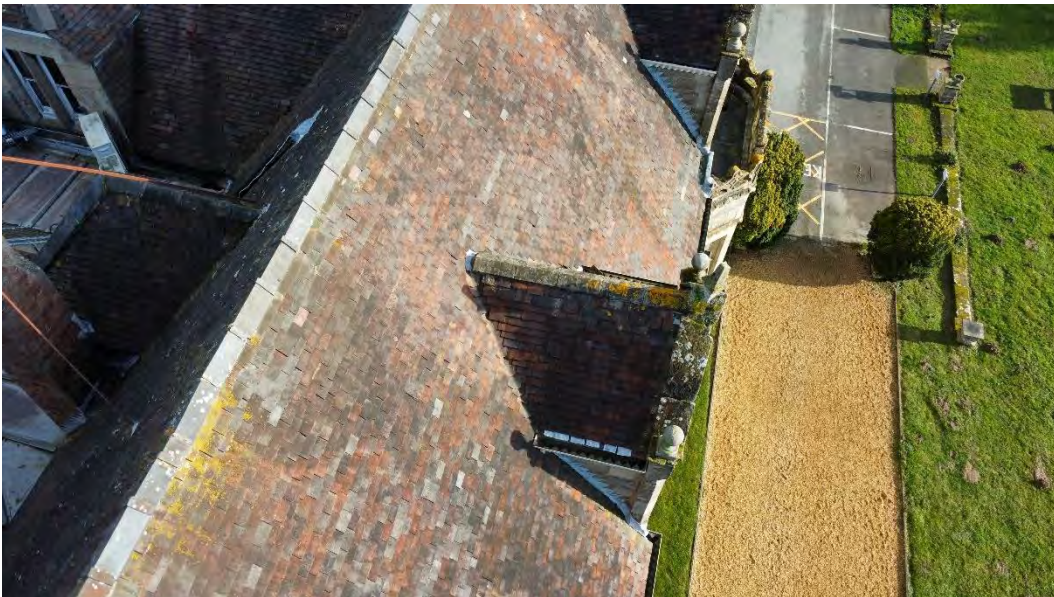
- Coping Stones and Finials
- 3.7.19 All parapet walls (gable ends and dormer windows) are topped with coping stones which have a heavy accumulation of moss and lichen growth. The coping stones have spalled, cracked or are heavily eroded due to their open exposure. The mortar joints are also deteriorated expediting the deterioration.

1020) Typical condition of coping stones and roof coverings

- 3.7.20 We recommend all stones are carefully lifted, cleaned and reinstated. The stones should then undergo appropriate mortar repairs and be repointed. A number of coping stones are beyond economical repair and an allowance for replacement like-for-like stones should be included.

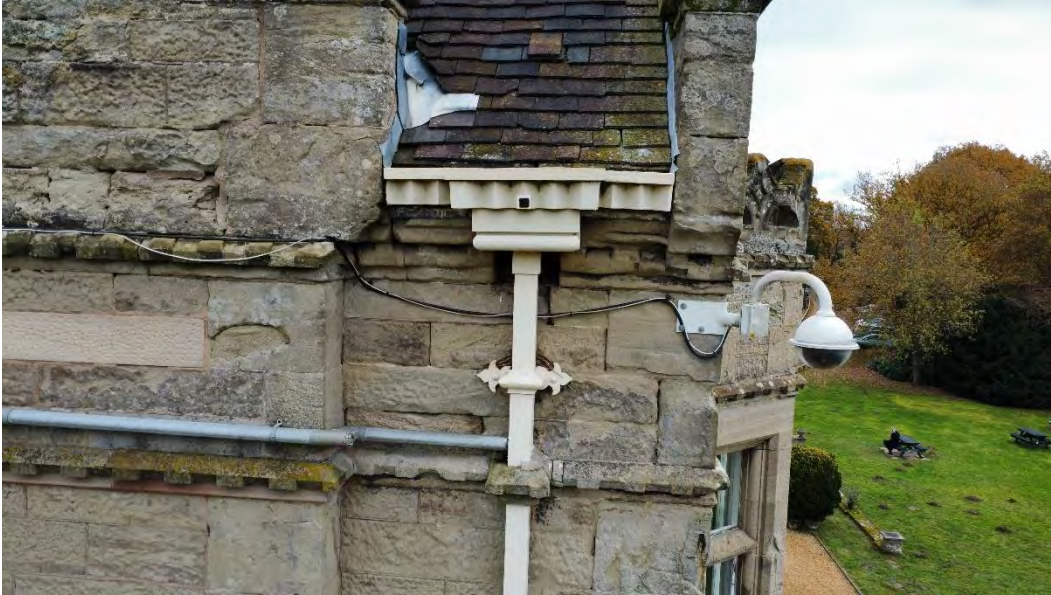
1021) Example where numerous stone defects are present ranging from requiring mortar repairs, armature repairs and replacement stone

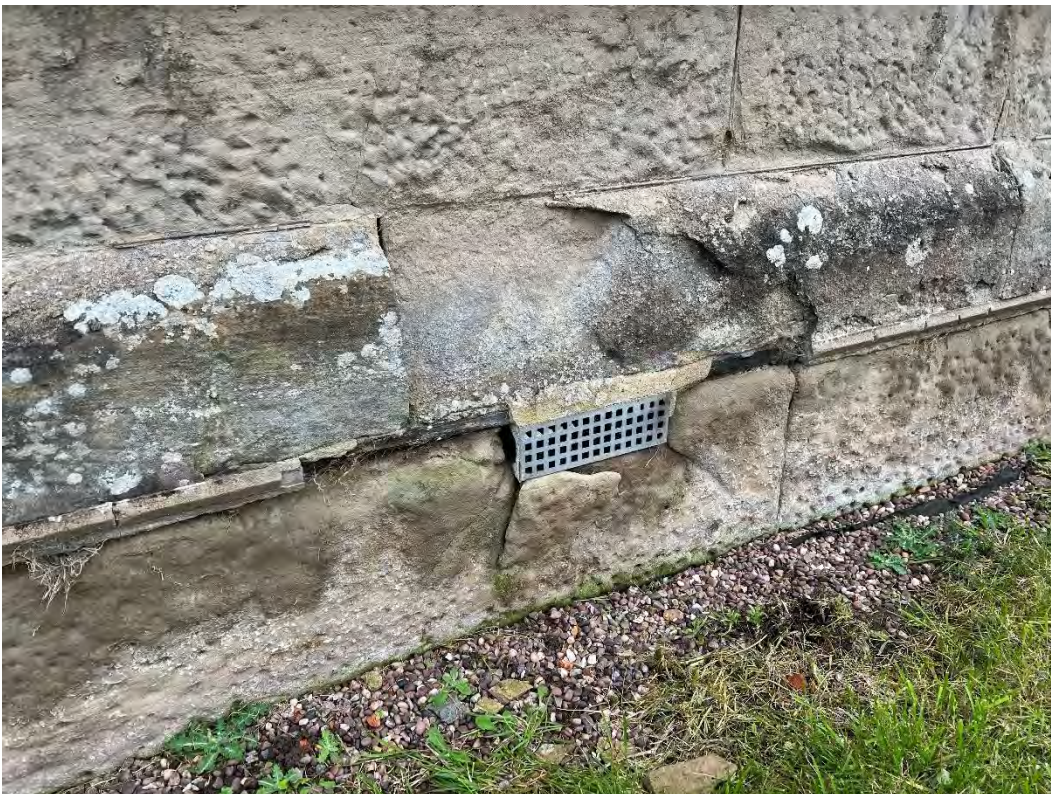
1022) Typical example where replacement stone required

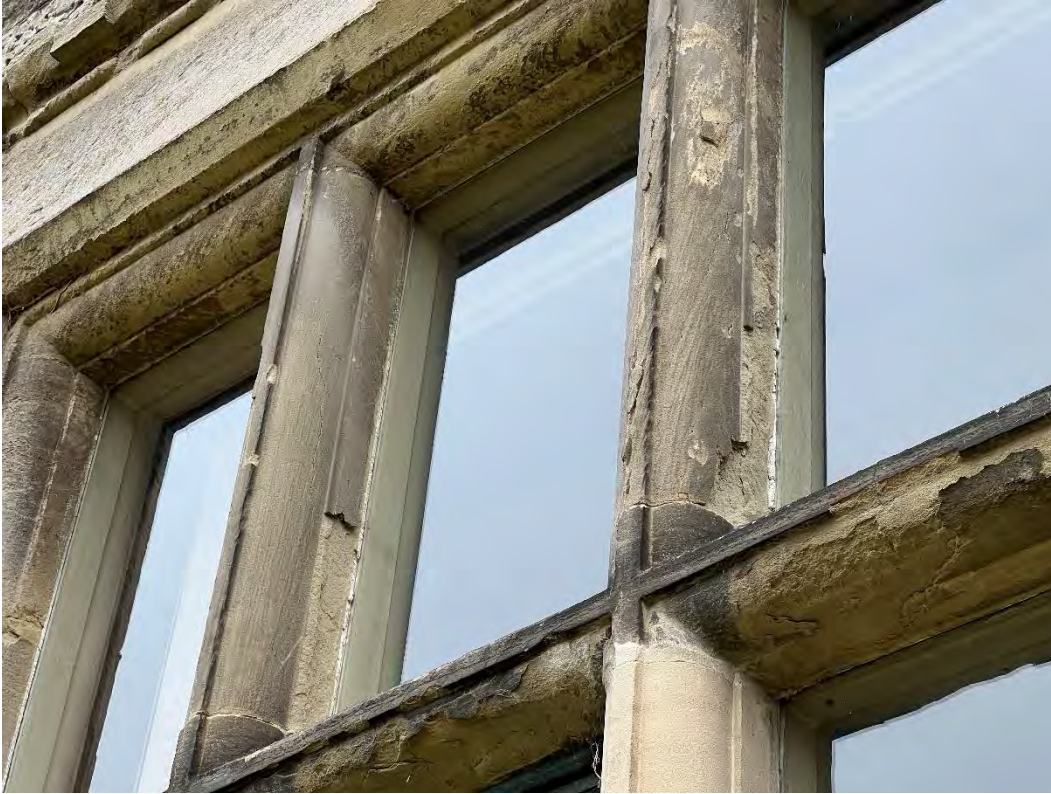
1023) Typical defect to stone window mullions

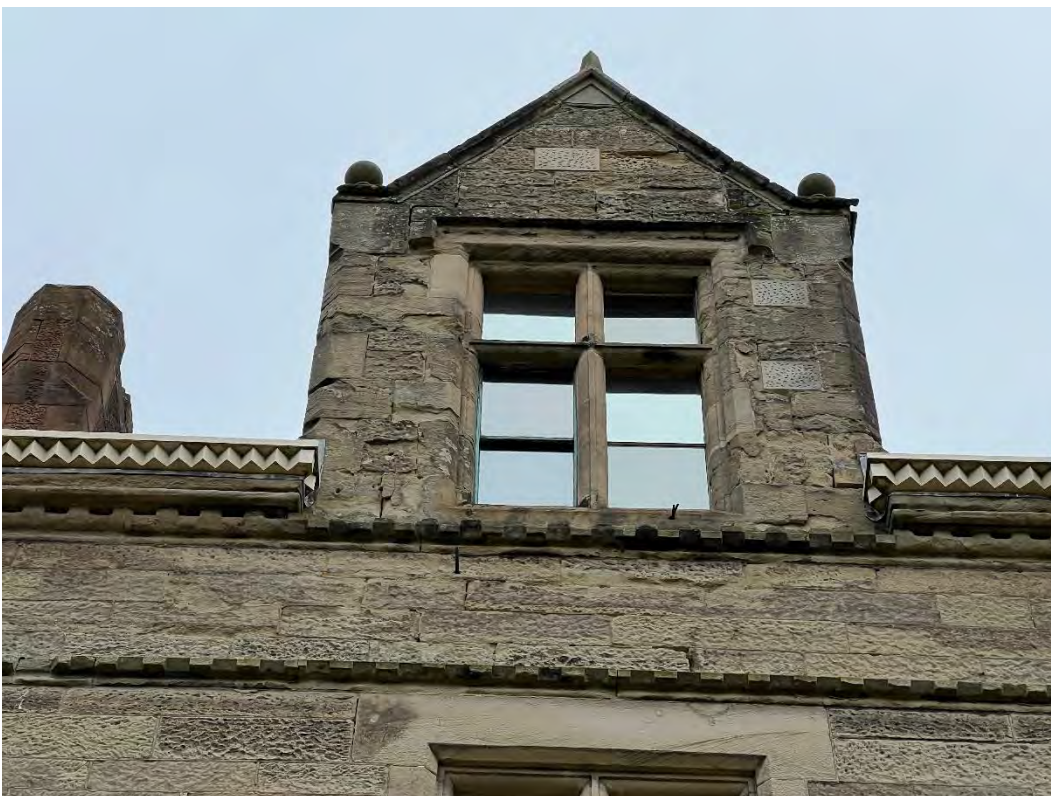
1024) Example where numerous stone defects are present ranging from requiring mortar repairs, armature repairs and replacement stone

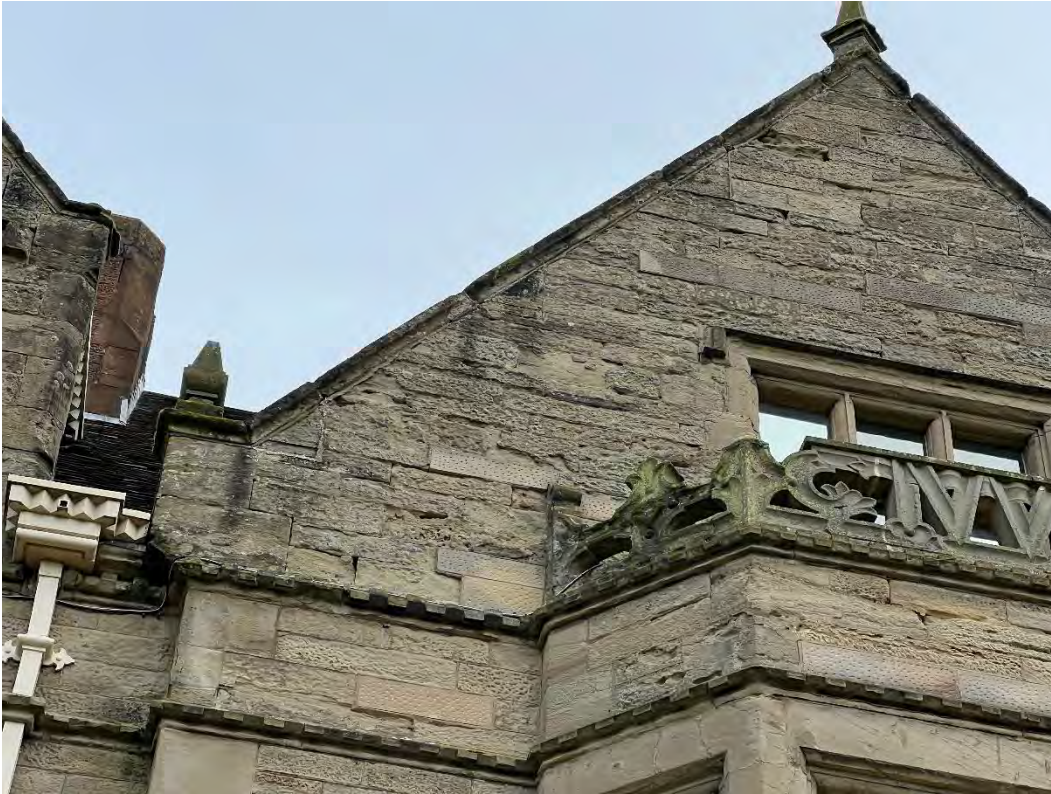
1025) Example where numerous stone defects are present ranging from requiring mortar repairs, armature repairs and replacement stone

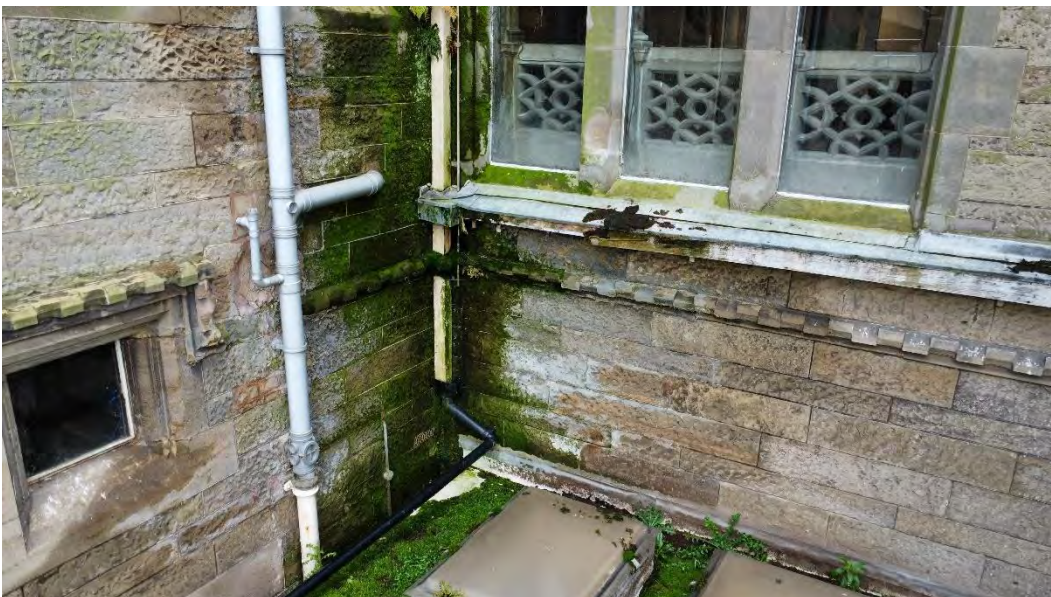
1026) Heavy water damage to stonework with algae and moss growth

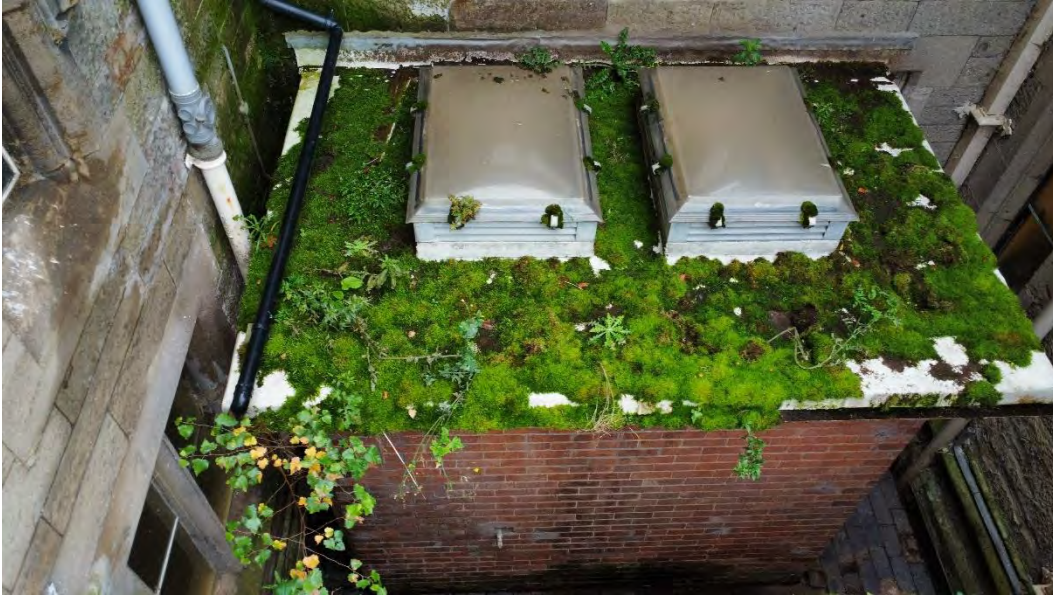
- 3.4.28 As the roof covering is heavily concealed by moss growth, we have been unable to determine the condition. The moss should be cleared and then the roofs assessed.

1027) Heavy moss growth to WC roofs

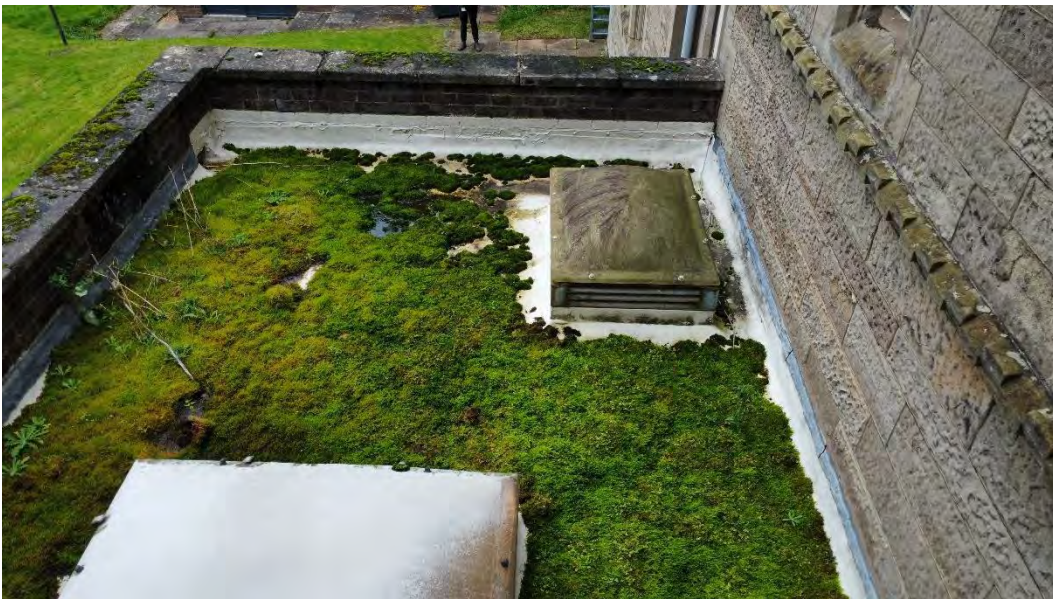
1028) Heavy moss growth to WC roofs – missing flashing to left hand side parapet

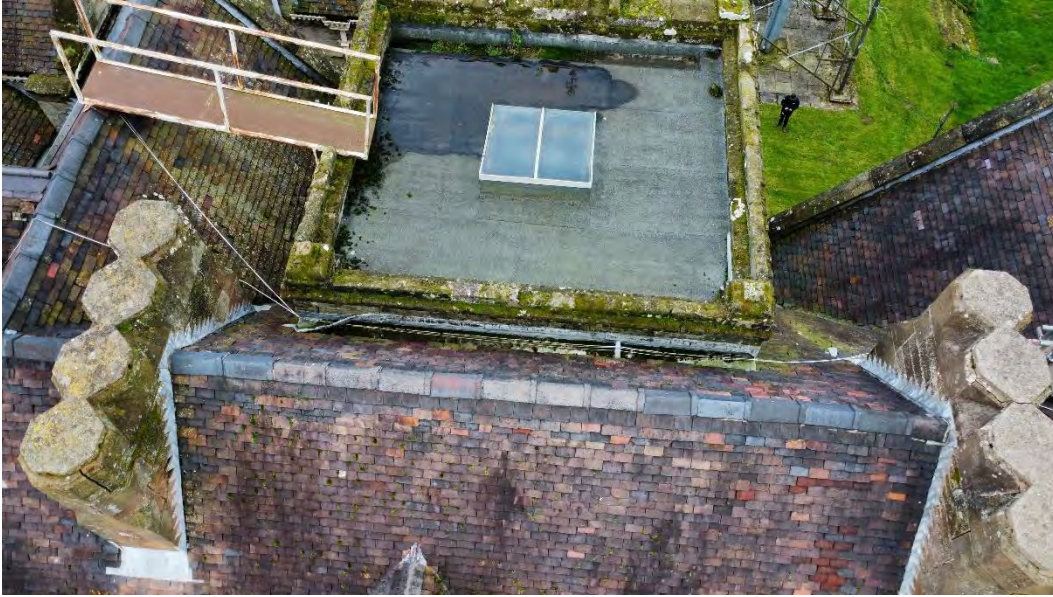
1029) Disconnected leadwork behind flat roof

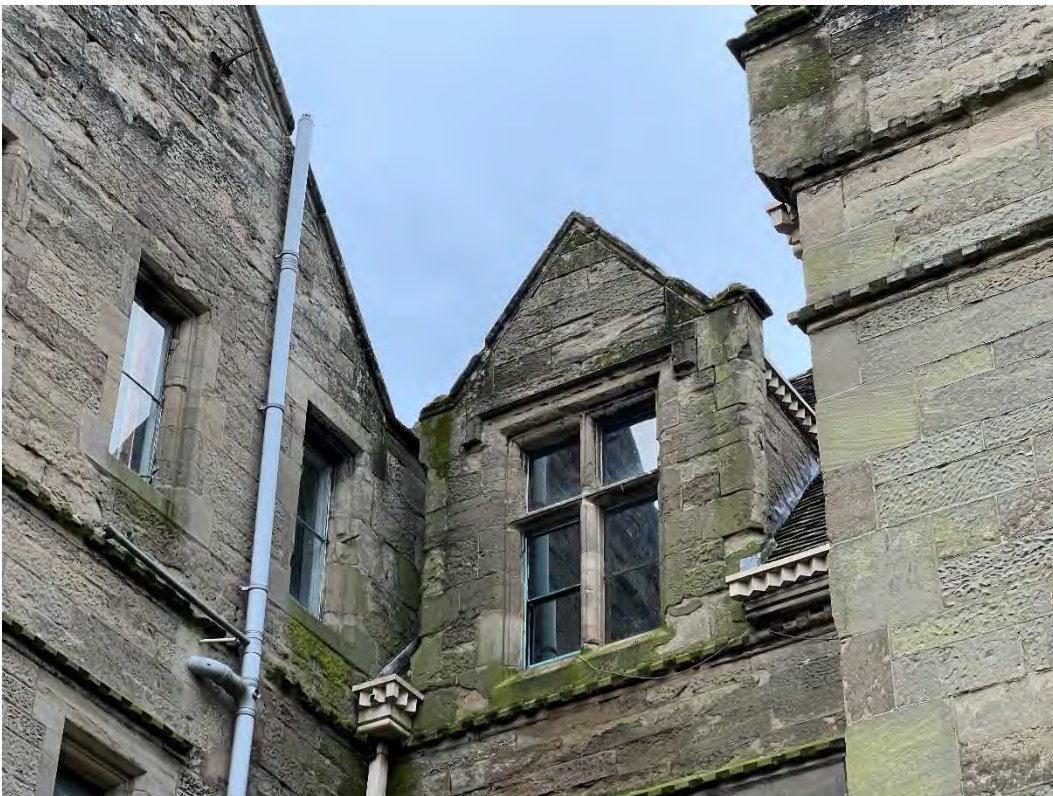
- 3.7.21 The parapets are also topped with finials, most of which are also heavily eroded and spalled. Isolated finials have been renewed and others are either loose or missing.

1030) Deteriorated coping stones and missing finials

- 3.7.22 All finials should be checked to ensure they are secure. Where loose these should be carefully removed and reinstated using dowels and bedded. All finials require repointing and mortar repairs as required.

- 3.7.23 Where finials are missing, replacement is not necessary but we recommend new stones are supplied and installed to retain the character of the building.

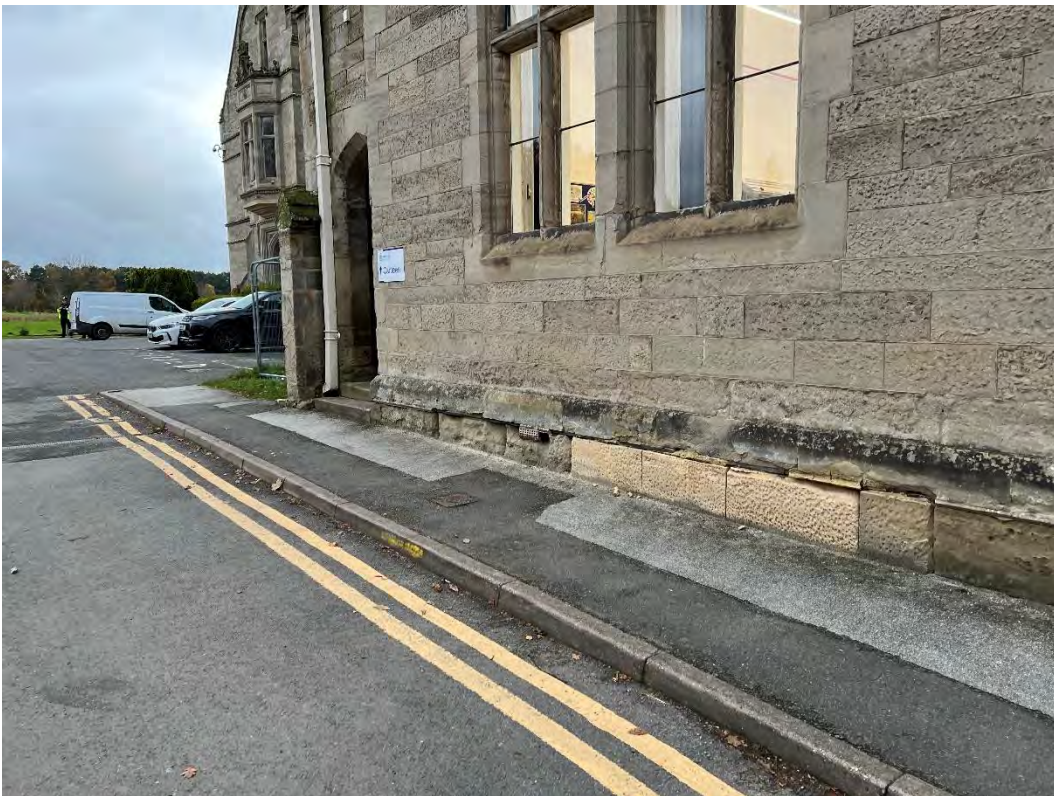
1032) Heavily eroded stones

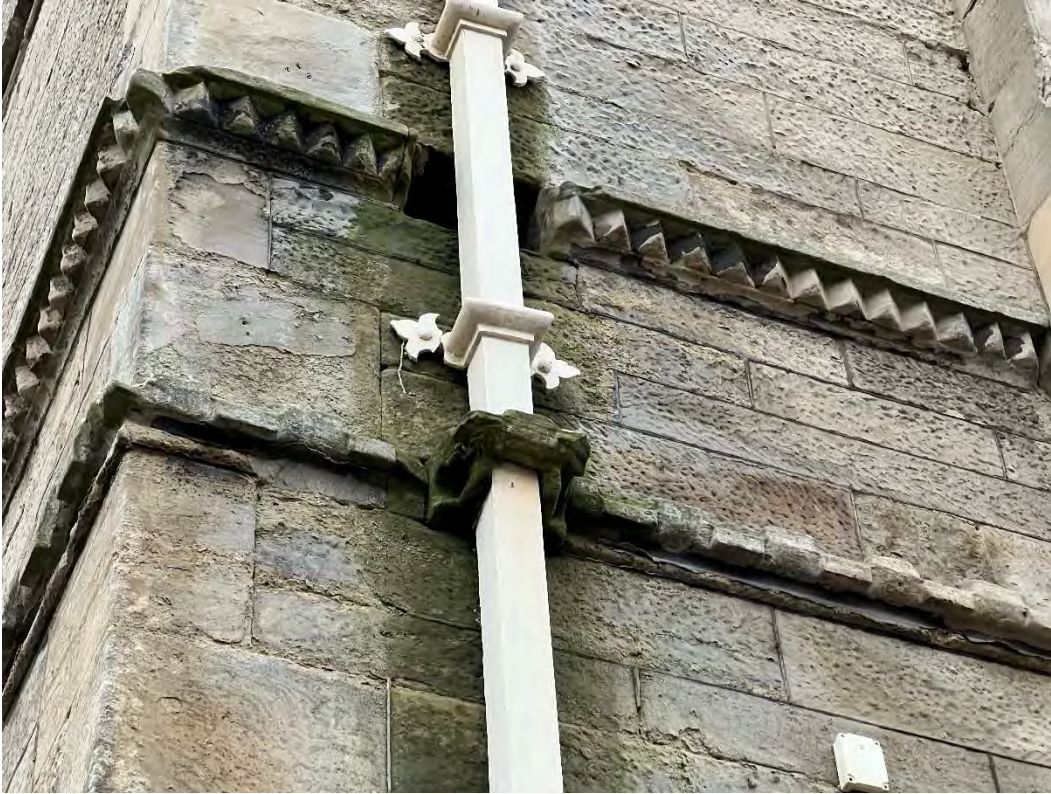
1033) Typical example where string bands are heavily deteriorated and/or missing

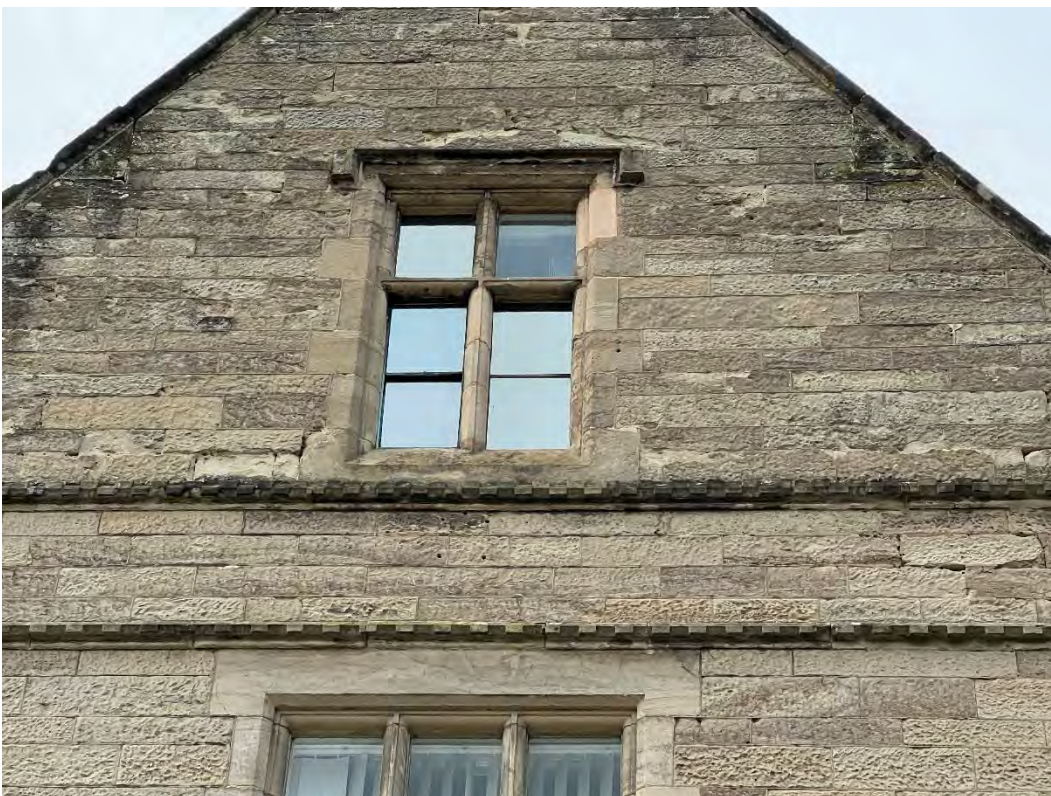
1034) Example where numerous stone defects are present ranging from requiring mortar repairs, armature repairs and replacement stone

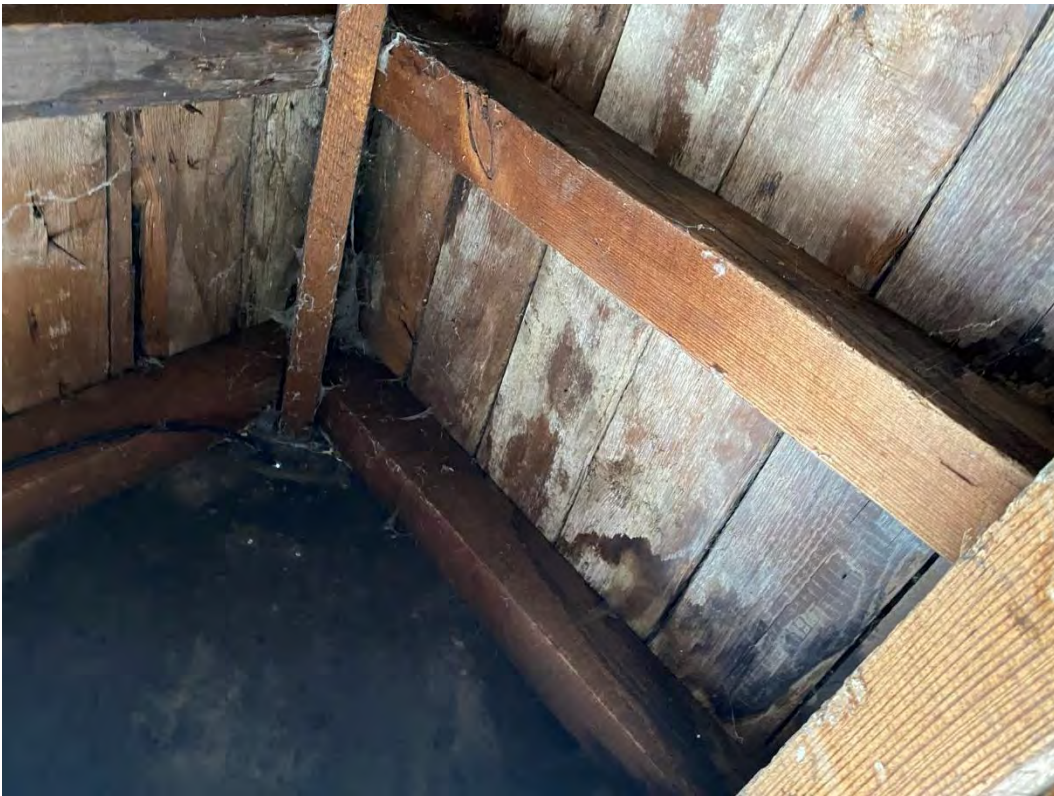
3.4.6 In addition to the above, there is staining to the timber sarking boards in random locations throughout the voids and concentrated moisture staining to roof timbers predominantly at ridge level and along box and valley gutter details. This indicates leaks through the roof covering but all timbers appear to be structurally sound and therefore we have allowed for repairs to roof coverings but minimal intervention to the roof timbers. Upon replacing roof tiles/ridges damage and decay may become apparent to the sarking boards and we therefore recommend included a suitable Provisional Allowance/Contingency for such repairs.

1036) Typical example of moisture stained sarking boards

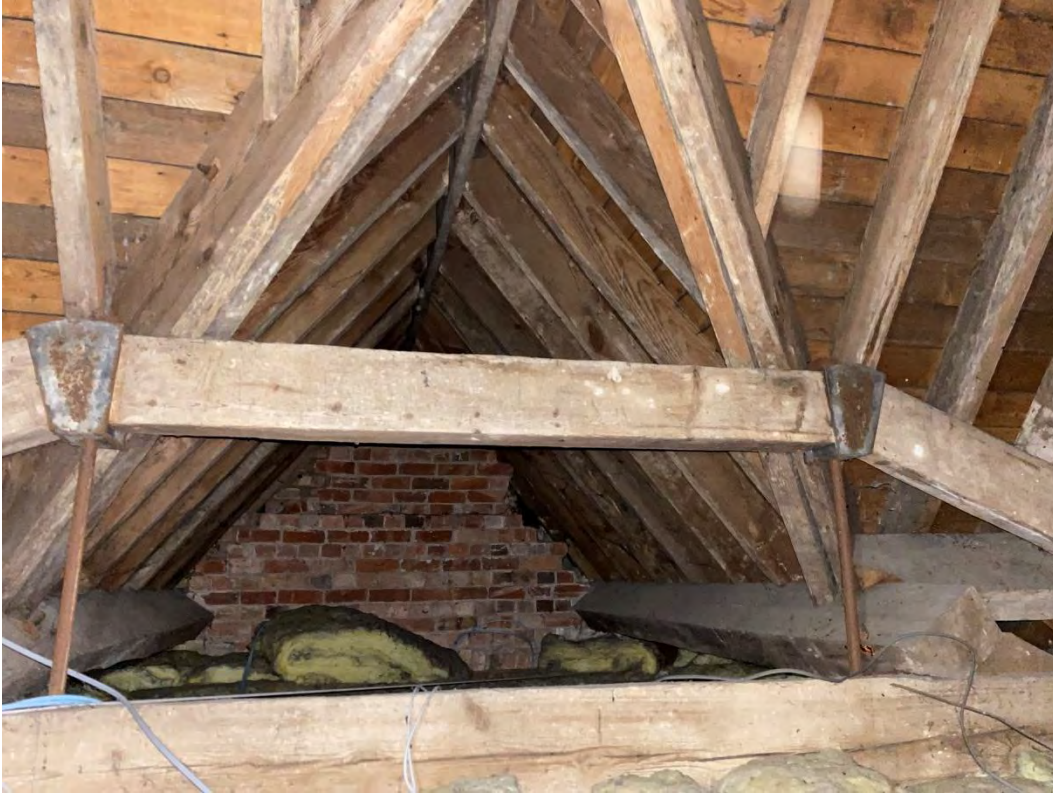
3.3.3 Retrofitted structural supports and bracing has been added within the roof voids, however, we did not identify any significant undulation or distortion to the roof structures or pitch coverings to raise any causes for concern. We recommend a Structural Engineer undertakes an assessment of the retrofitted supports to ensure they are satisfactory and now further remedial works are required.

1037) View of retrofitted supports within roof void

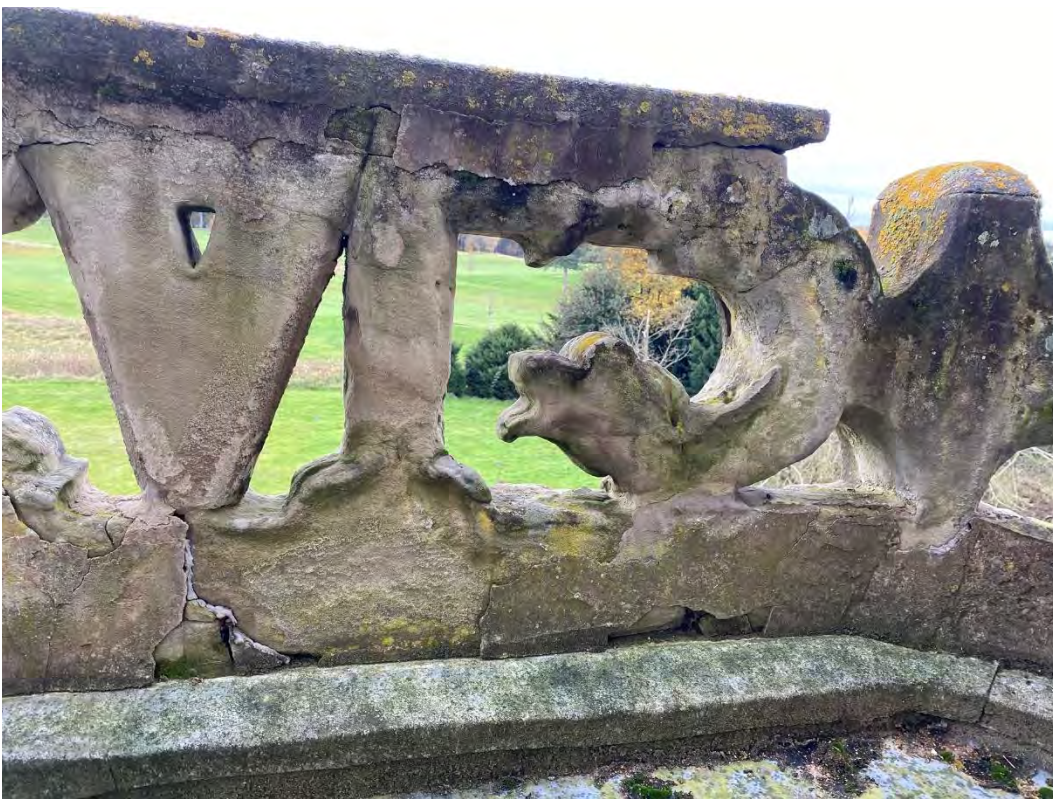
1038) Close up of ornate balustrades in poor condition

- 3.7.16 To certain locations, such as the ornate balustrading, following repair the application of a shelter coat will provide a sacrificial layer to reduce the rate of deterioration. This is recommended as an optional item but testing will be required to ensure the appropriate coating is used compatible with the existing stonework.
