Woodcote House, Leek Wootton, Warwick, CV35 7QA

Condition Survey Report for
Warwickshire Police and Crime Commissioner
December 2023
Our Ref: AR/23-02515

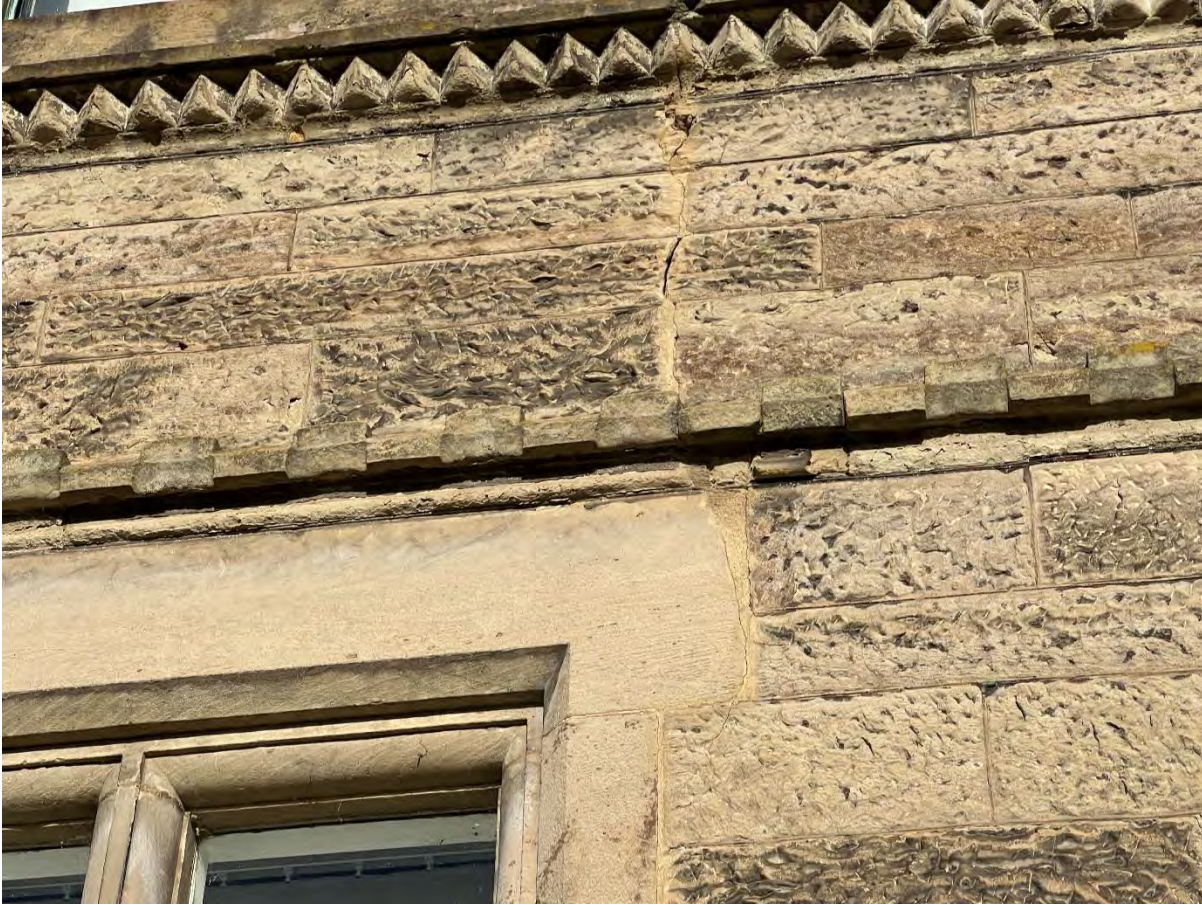
3.3.1 Rapleys have not undertaken a review of the structure within the property however, we did identify cracking to the masonry to both the South (Left) and East (Front) elevations. These cracks appear to run between windows and may be the result of failing concealed lintels. Stitching repairs are anticipated during the stone repair works however we recommend a Structural Engineer is appointed to undertake a review of the cracking and possible repairs required.

1039) Cracking to left hand side (south) elevation
